Carriage Club HOA
Lone Tree, CO

Report #: 19227-3
Beginning: January 1, 2024
Expires: December 31, 2024

RESERVE STUDY
Update "With-Site-Visit"

April 12, 2024

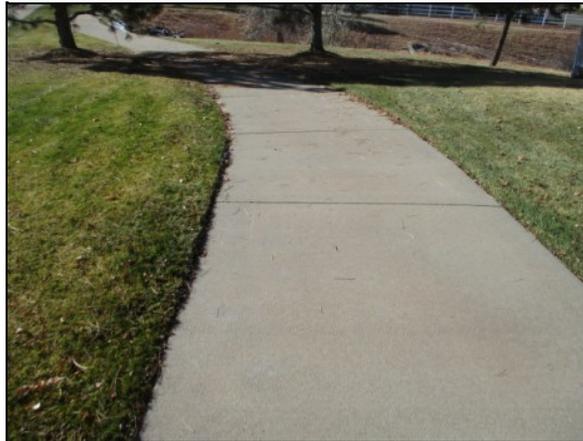
Comp #: 2115 Concrete Walkways - Repair - 5%

Comments: Concrete sidewalks determined to be in fair condition typically exhibit minor changes in slope and a moderate percentage of cracking and surface wear. Trip hazards may be increasing in frequency and severity and should be closely monitored to prevent further risks. Colorado is home to expansive soils. One of the causes of concrete damage in this type of soil moisture. Expansive soils tend to swell in size when wet and contract as they dry out. As the soil expands and contracts it can create enough force to cause major damage to sidewalks. Repair any trip and fall hazards immediately to ensure safety. As routine maintenance, inspect regularly, pressure wash for appearance and repair promptly as needed to prevent water penetrating into the base and causing further damage. In our experience, larger repair/replacement expenses emerge as the community ages. Although difficult to predict timing, cost and scope, we suggest a rotating funding allowance to supplement the operating/maintenance budget for periodic larger repairs. Adjust as conditions, actual expense patterns dictate within future reserve study updates.

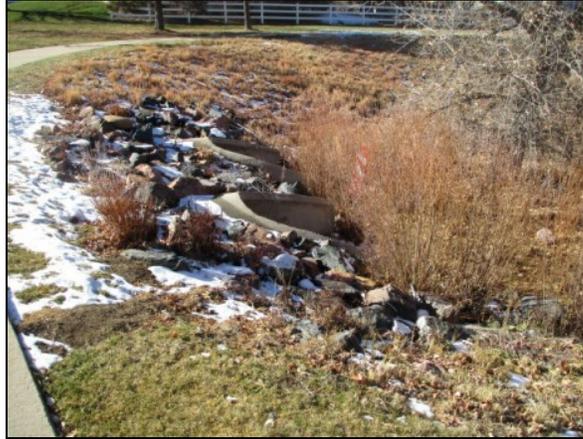
Comp #: 2117 Site Drainage System - Clean/Repair

Comments: Component funding included at the request of the client. System only requires routine repairs on an as-needed basis according to information provided. Based on observed conditions and/or reports by the Association, we recommend further investigation using cameras or other means to document and identify existing conditions. Some Associations consult with civil and/or geotechnical engineers in order to develop scopes of work for repair/replacement. If more comprehensive analysis becomes available, findings should be incorporated into Reserve Study updates as appropriate. An allowance for repairs is recommended here.
